**MOISTURE CONTROL AND INSULATION  
SYSTEMS IN BUILDINGS, CHILLED WATER  
PIPES AND UNDERGROUND PIPES**

*A Guide for Architects, Engineers, Contractors, Facility Managers,  
Construction Professionals and Homeowners*

**William Allen Lotz, P.E.**

### WET BUILDINGS: A MOISTURE PRIMER\*

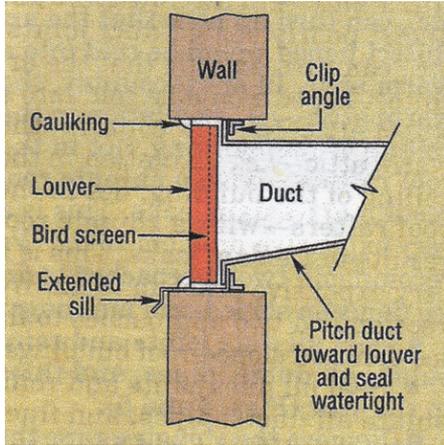
1. The engineer drew this good louver detail; the contractor ignored it and built the bottom of the duct flat. Caulk was “forgotten,” and the ducts leaked during most rainstorms. Nothing was watertight.

The HVAC specifications for louvers and exterior exhaust grilles should require caulk around each exterior mechanical penetration. The same is true for flashing around HVAC penetrations. We have seen several buildings where rain has leaked into the structure via the HVAC louvers. Fig. 1 shows a detail of a properly designed exterior wall louver installation. The engineer’s efforts, however, were defeated by the contractor. The required caulking between the louver and the wall was not done. Also, the bottoms of the ducts where they terminated at the louvers were made horizontal rather than pitched down toward the louver for drainage (Fig. 2). As a result, water leaked into the building during most rainstorms through these exterior duct penetrations (Fig. 3).

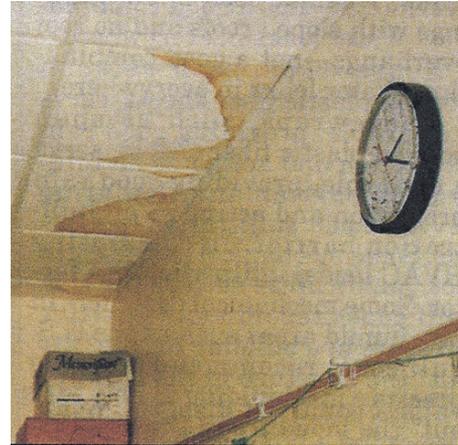
3. Leaks stained the acoustical ceiling under most of the outside air ducts shown in Fig. 2.

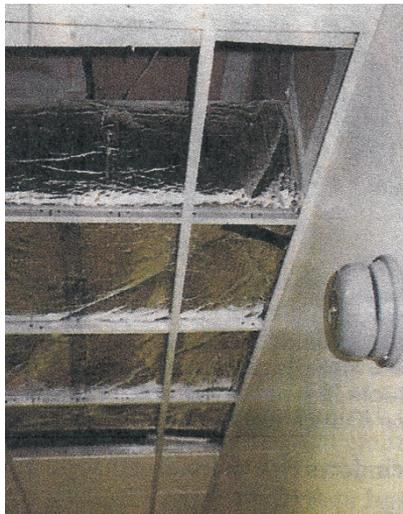
2. The engineer designed the classroom outside air grilles as shown in Fig. 1. This photo shows the actual installation. The contractor claimed there was not enough room to slope the bottom of the duct. The ducts could have been offset, however; close to the wall or possibly installed at a slightly higher elevation.

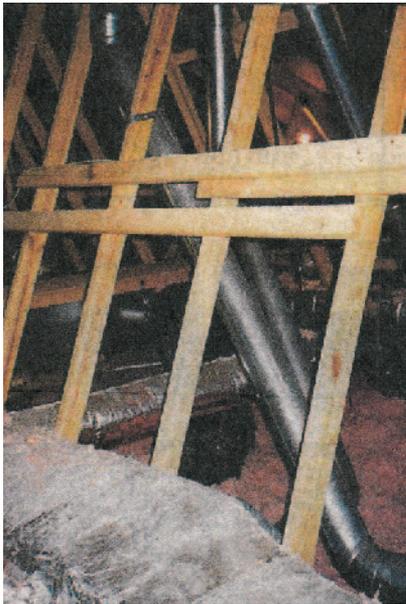
4. Uninsulated bathroom exhaust ducts in a nursing home resulted in ice dams and leaks.

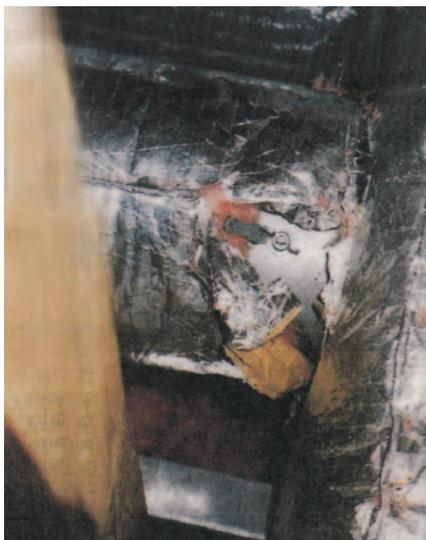
5. The duct joints were poorly sealed, and there were many gaps in the duct insulation. The attic was warm as a result, and ice dam leaks were everywhere.

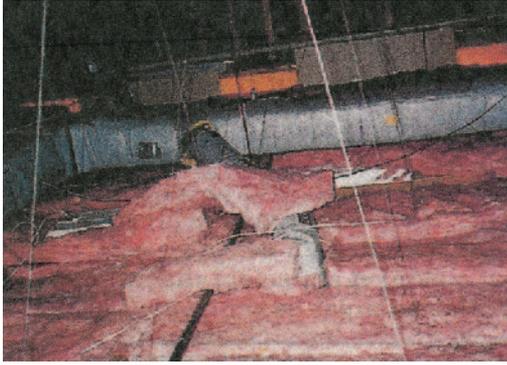
6. Attic in office building. Battens on acoustical ceiling resulted in almost zero  $R$ -value due to air flow through the ceilings and batts.

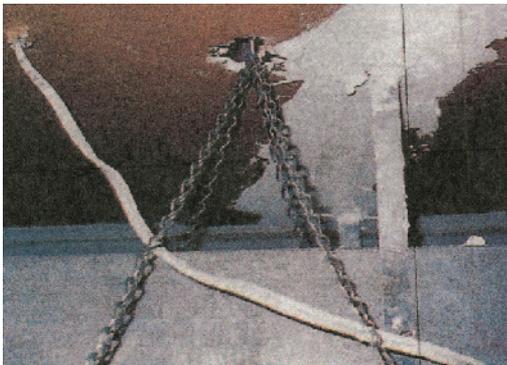
7. Holes in sheet rock, vapor barrier and insulation for lighting fixture support resulted in heat loss, condensation and staining.

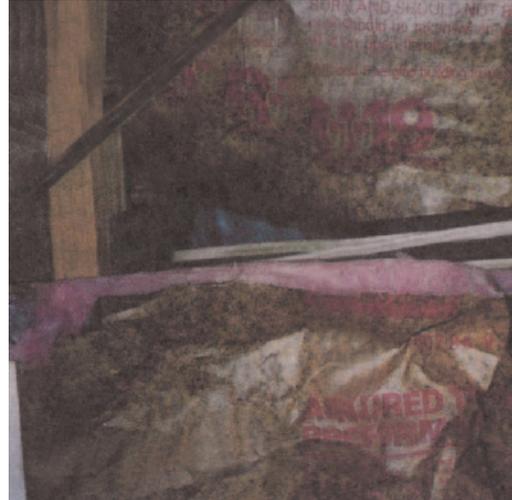
9. Battens above acoustical ceiling. There is no continuity of insulation or vapor barrier, and the Kraft facer violates code for fire resistance.

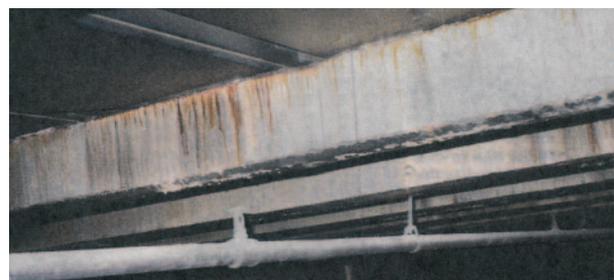
10. Severe purlin corrosion in this trash-to-energy plant resulted from constant condensation. Owner paid to sandblast and repaint almost yearly to no avail.

Cheap solutions are not viable for this type of severe condensation environment. Our solutions have included glass fiber reinforced plastic (FRP) panels, stainless-steel fasteners and factory-made isocyanurate panel systems.

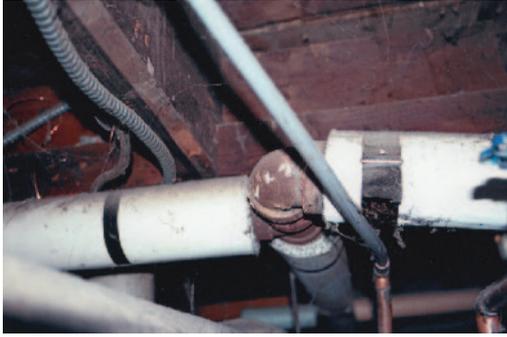
11. Asbestos aircell insulation. If you encounter it, call the abatement contractor immediately.

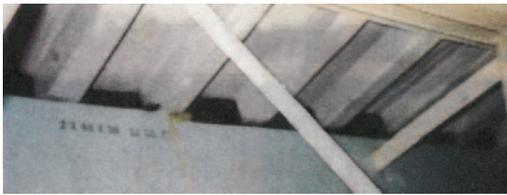
12. Typical lack of detail above acoustical ceiling resulted in costly damage. There should have been both insulation/vapor barrier in the roof flutes.

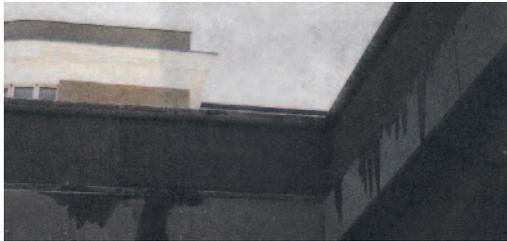
13. Damage to building exterior due to interior details shown in Fig 11. The masonry deteriorated, and the steel rusted.

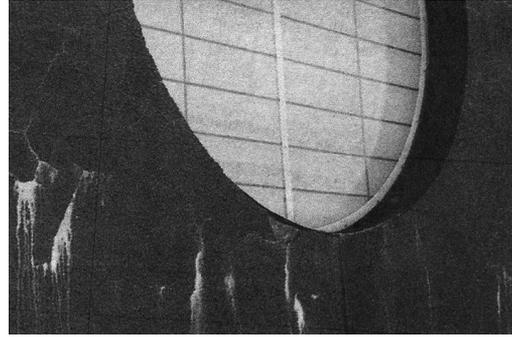
14. Severe wall damage and stucco failure as a result of no wall vapor barrier before the inside surface of the extruded polystyrene insulation.

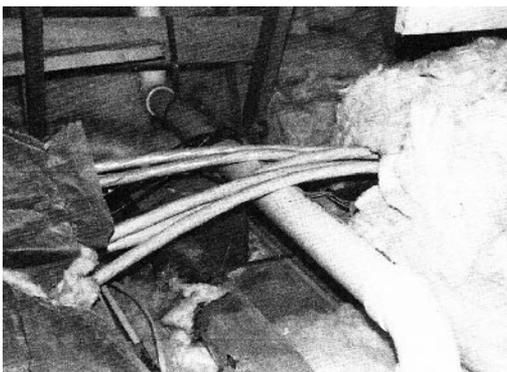
**Photo A.** Ceiling above bathroom (note exhaust fan). Ceiling was covered with black mold due to missing insulation and non-use of exhaust fan.

The owner became concerned when he found frost in the attic under the few two-by-eight lumber boards that were used as a walkway on top of the ceiling joists. The problem was caused by the lack of a vapor retarder in the ceiling. The solution was to install polyethylene membrane under the fiberglass batts.
